## Fiberglass-batt insulation

## LABELED VS. REAL-WORLD PERFORMANCE

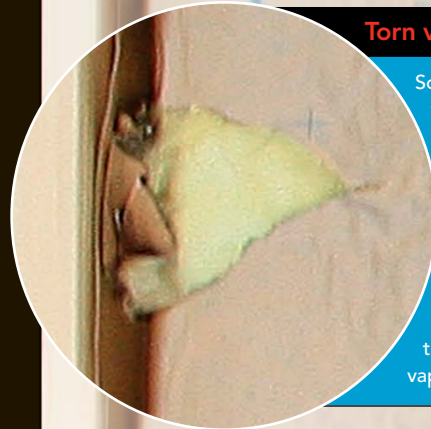
### Torn vapor retarder

Some installers mishandle the batts and rip their vapor-retarder facing. Don't worry about small tears, but if there are large holes in the facing, repair them with housewrap tape before hanging the drywall to restore the integrity of the vapor retarder.

### Sloppy utility detail

Batts should be cut precisely so that they fit snugly around electrical boxes, and they should be split and fitted around wires and pipes so that the fiberglass is not compressed, which would reduce its R-value.

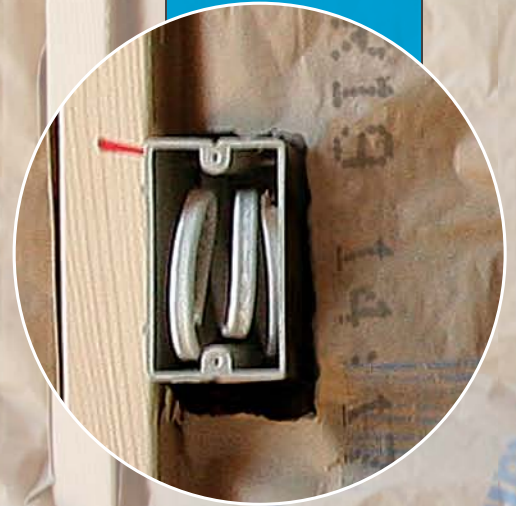
### Compression

Batt compression diminishes rated R-values. Most R-19 batts (R-3.04 per in.) are 6¼ in. thick. When the batt is compressed into a 5½-in.-deep stud cavity, the overall R-value decreases to R-18. The R-value per inch increases to R-3.27, but the overall R-value is what really matters. Stuffing a batt into place or pinching it behind obstructions reduces its overall R-value even more.

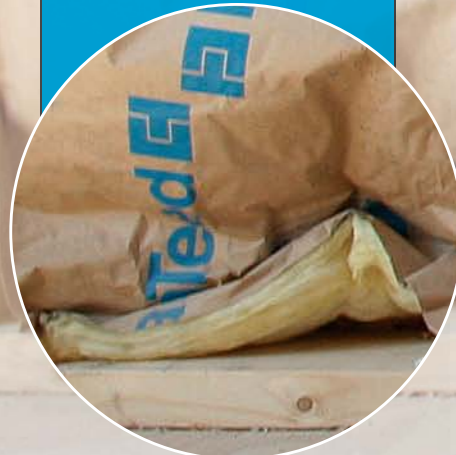
R-19-labeled batts don't create R-19 walls. Studies at Oak Ridge National Laboratory show how conventionally framed 2x6 walls filled with standard, low-density R-19-labeled fiberglass batts actually perform (graph below).

The Oak Ridge National Laboratory study looked at whole-wall R-values, which take into account flaws in batt installation and the variety of structural elements that make up approximately 25% of the wall, such as studs, headers, and sill plates. The findings show that a 2x6 wall insulated with R-19 fiberglass batts that have been installed perfectly actually performs at an R-value (12.8) that's more than 30% lower than what the labeled R-value suggests.

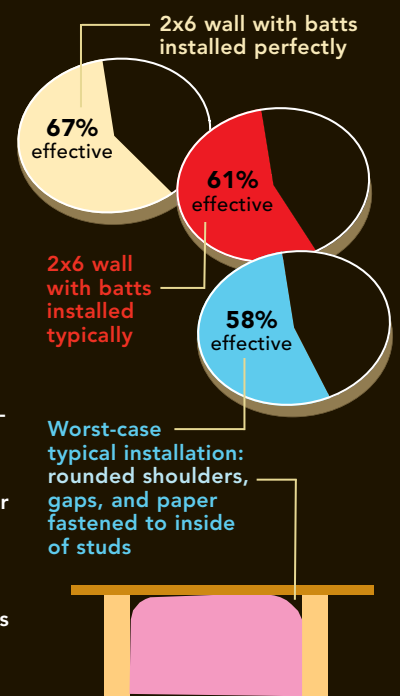
### Incorrect fastening

Batts with vapor-retarder facings should be stapled to the face of the studs. Otherwise the batts become overly compressed along their edge, which reduces their overall R-value further.

### Gaps

Gaps between framing and batts can lead to energy losses and comfort and durability issues due to condensation that forms in the wall when warm air comes into contact with cold, exposed surfaces.

A fiberglass batt will perform best if it's installed in an airtight cavity and if it's in full, uniform contact with the interior or exterior sheathing, as well as the studs and top and bottom plates.
